Where did you say was the landslide?

By Lt Col E.H. Jacobs, SO1 Fixed Assets Manager, RFIM Durban

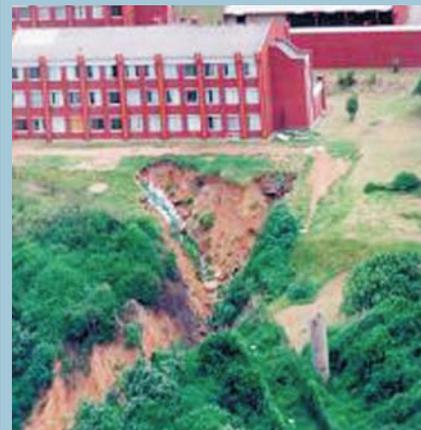
Fixing soil erosion.

To prevent further headward erosion towards E Block a combination of gabion baskets, Reno mattresses, non-woven geotextiles and vetiver grass (*Vetiveria zizanioides*) was being used. The objective is to inhibit erosion so that the natural vegetation can re-establish itself and ultimately cover all of the repair materials. The vetiver was planted in a succession of steps, or small terraces (about 309 mm high by 600 mm wide). It was constructed along the base of the gully to cover the buried storm-water drain. The purpose is to reduce the velocity of surface run-off so as to inhibit erosion and encourage the deposition of sand washed down from the sides of the gully.
